Manhole Inspection Summary

Manhole # S25Q__017MH

Insp Date: **4/8/08 2:13 PM**

Location Address: **1411 BUSH ST.**

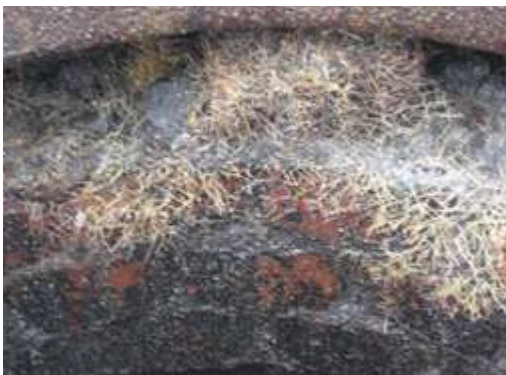
Defect 2

MISSING MORTAR AND BRICKS WITH EVIDENCE OF INFILTRATION AND ROOT INTRUSION

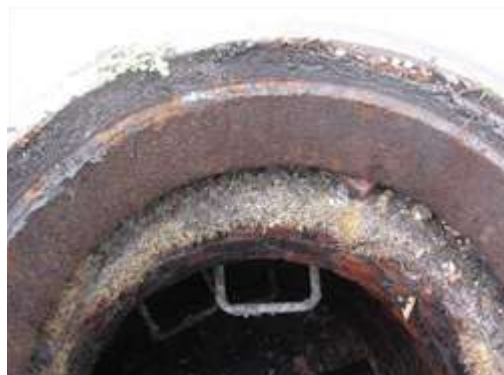
Defect 1

Frame Offset: **1.5** (in.) Condition: ☒ Sound ☐ Cracked ☐ Leaks

1.5 IN FRAME OFFSET

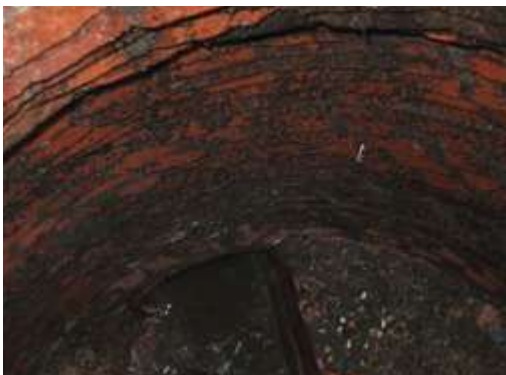
Defect 7

Infiltration: ☐ None ☐ Joint ☐ Cracks ☐ Mortar ☐ Roots ☒ Wall

EVIDENCE OF BARREL INFILTRATION

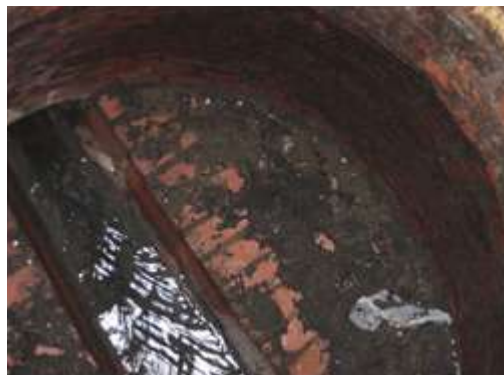
Defect 6

Condition: ☐ Sound ☐ Cracked ☐ Root Intrusion ☐ Deteriorated ☐ Leaks ☒ Debris

DEBRIS ON THE BENCH

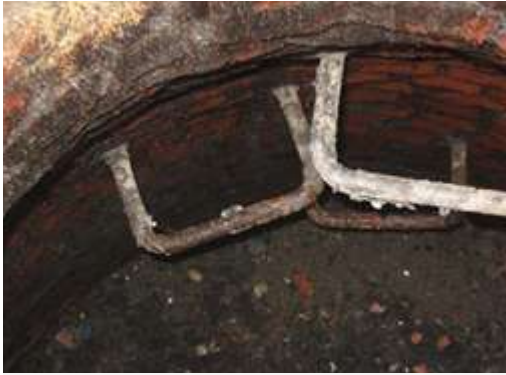
Defect 5

Steps Count: **3** Missing: **0** ☒ Corroded

EVIDENCE OF INFILTRATION AND
CORRODED STEPS

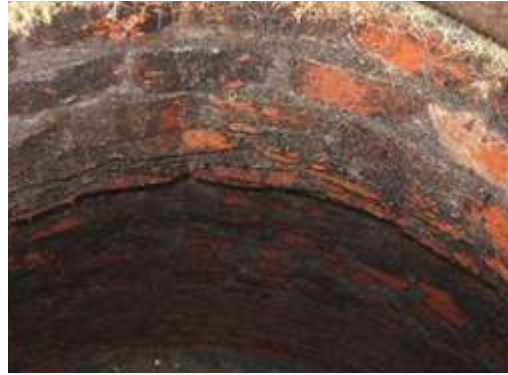
Defect 4

Infiltration: ☐ None ☐ Joint ☐ Cracks ☐ Mortar ☐ Roots ☒ Wall

EVIDENCE OF INFILTRATION ON
CORBEL WALL AND ROOT INTRUSION
AT CHIMNEY

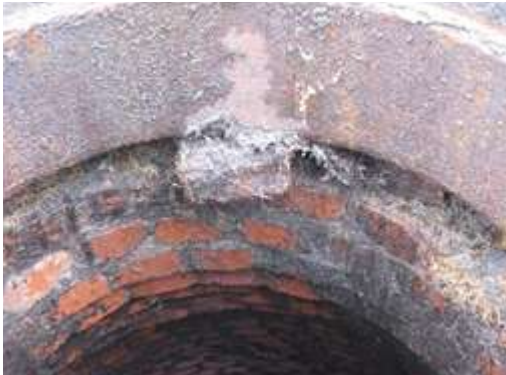
Defect 3

Condition: ☐ Sound ☐ Cracked ☒ Root Intrusion ☒ Loose Brick ☒ Deteriorated

Infiltration: ☐ None ☐ Joint ☐ Cracks ☒ Mortar ☒ Roots ☒ Wall

Loose Bricks and Deterioration in
Chimney, Chimney Infiltration

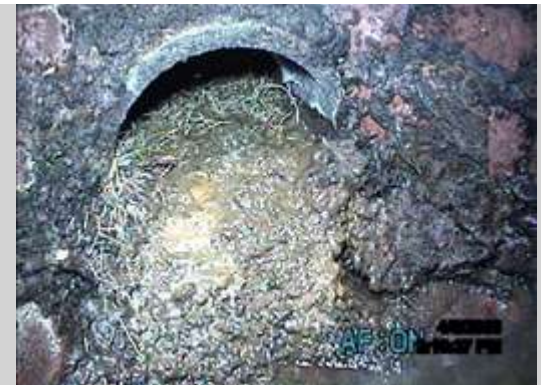
5 O'Clock Inflow

Comments **5 O CLOCK ALMOST FILLED WITH ROOTS AND SLUDGE**

SERVICE LATERAL WITH ROOT
INTRUSION AND HEAVY SLUDGE

Pipe Height: **6** (in.) Rod and Bar (Angled)
Pipe Material: **Clay** ☐ Pipe Lined
Invert Depth: **7.65** (ft.) Flow Characteristics: **None**
Deposits: ☐ None ☐ Mud ☒ **Sludge** ☐ Debris ☐ Grease
Silt Depth: **4** (in.) Deposits Extent: **Heavy**
Infiltration: **Evidence** Pipe Seal Cond: **Unknown**
